Navajo Abandoned Uranium Mine

Site Screen Report

Lower Canyon AUM Site

March 2010

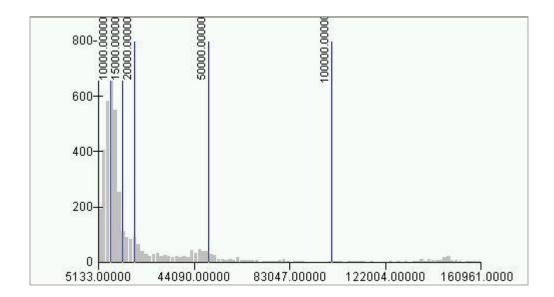
A total of 4,108 gamma radiation measurements were collected from the mine site, ranging from 5,133 cpm to 160,961 cpm. Measurements in the vicinity of the waste debris were found at levels in up to 120,000 cpm. The measurements are represented in Figures 1 and 2.

The following chart and statistics were generated by ESRI ArcGIS 9.3.1, and show the general distribution of the site gamma radiation measurements. The horizontal X axis represents the gamma radiation reading levels in cpm (lowest levels to the left). The vertical Y axis represents the frequency of each gamma radiation level.
